# Manhole Inspection Summary

Manhole # S02YY1009MH

Insp Date: **8/11/06 12:00 AM**

**Location** Address: **3701 Bancroft Rd** Cross Street: **Fieldcrest Rd**

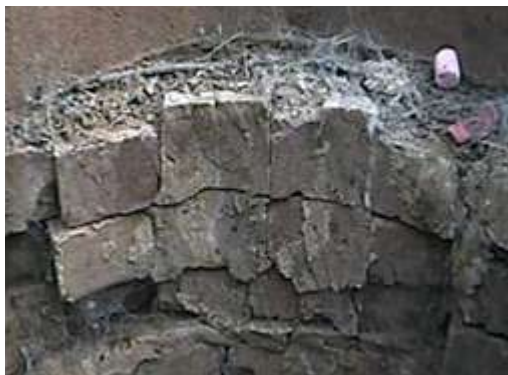
adjustment

**Chimney / Frame Adjustment** ☒ Exists Material: **Brick** ☐ Parged Height: **9** (in.)  
Condition: ☒ Sound ☐ Cracked ☐ Root Intrusion ☐ Loose Brick ☐ Deteriorated  
Infiltration: ☐ None ☒ **Joint** ☐ Cracks ☒ **Mortar** ☐ Roots ☐ Wall

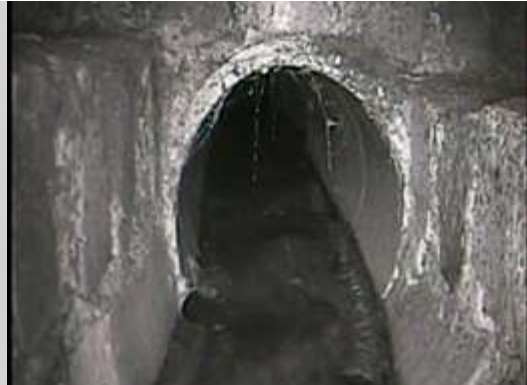
### 8 in. Circular Gravity Sewer Pipe Out @ 12 O'Clock

Pipe Material: **Clay** ☐ Pipe Lined

Invert Depth: **10.20** (ft.) Flow Characteristics: **Slow**

Deposits: ☒ None ☐ Mud ☐ Sludge ☐ Debris ☐ Grease

Infiltration: **None** Pipe Seal Cond: **Sound**

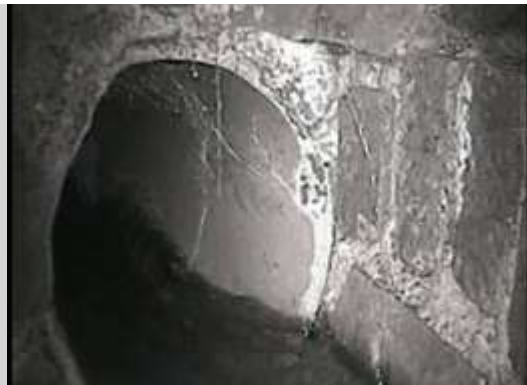
### 8 in. Circular Gravity Sewer Pipe In @ 4 O'Clock

Pipe Material: **Clay** ☐ Pipe Lined

Invert Depth: **10.10** (ft.) Flow Characteristics: **Slow**

Deposits: ☒ None ☐ Mud ☐ Sludge ☐ Debris ☐ Grease

Infiltration: **None** Pipe Seal Cond: **Sound**
